**Flood Control Project Maintenance
Levee Inspections**
LMA District Cover Sheet
Spring 2019 Levee Inspection Results

Sutter Maintenance Yard Maintenance Area 0007

Levee Inspection Report By Mile - Spring 2019

Waterway	Bank	Unit Miles	Inspection Start/End	Inspector
Unit No. 01 Feather River	Right	11.90	04/04/2019 04/04/2019	Sterling York

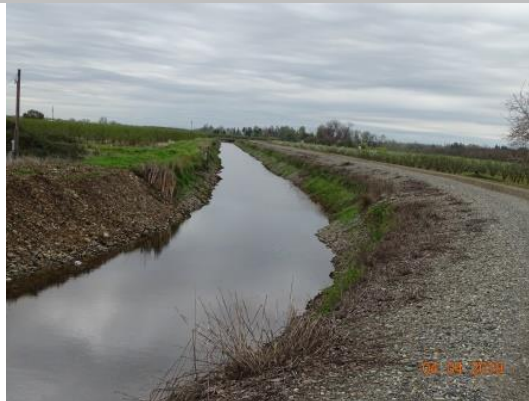
Photo 1 of 1 : SP_2019_MA0007_200_10_20190409_00028.jpg

LM Start	0.00	Rating **	A	Issue No.	10
LM End	11.89	Issue Type +	Ma	Location *	LS
Category	Earthen Levee			GPS Latitude/Longitude	
				Start	End
Item	Vegetation			39.310938 °	39.439672 °
				-121.637634 °	-121.641504 °
DWR ID	DWR_MA0007_01_s_2019_10				
Comment Code					
V1 : Control annual grass and weeds on the levee slopes and easements.					
Inspector Comment					
The annual vegetation is well maintained, Spring 2019.

View looking upstream landside at the well maintained vegetation alongside the irrigation ditch, Spring 2019.

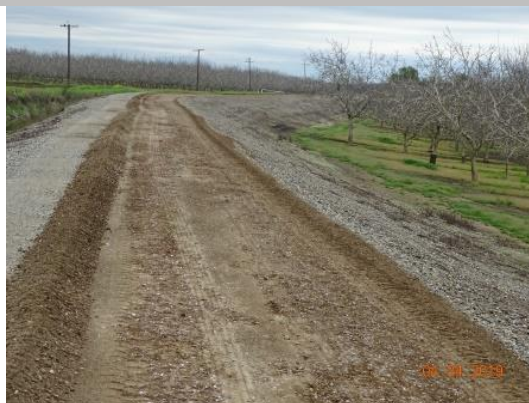
Photo 1 of 1 : SP_2019_MA0007_200_11_20190409_00029.jpg

LM Start	0.00	Rating **	A	Issue No.	11
LM End	11.89	Issue Type +	Ma	Location *	WS
Category	Earthen Levee			GPS Latitude/Longitude	
				Start	End
Item	Vegetation			39.310938 °	39.439672 °
				-121.637634 °	-121.641504 °
DWR ID	DWR_MA0007_01_s_2019_11				
Comment Code					
V1 : Control annual grass and weeds on the levee slopes and easements.					
Inspector Comment					
The annual vegetation is well maintained, Spring 2019.

View looking upstream waterside at the well maintained vegetation and re-grading of the levee crown, Spring 2019.

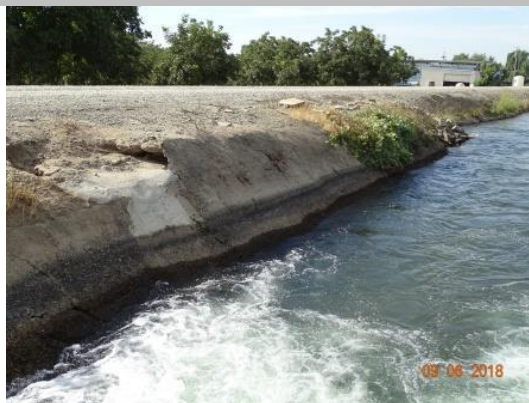
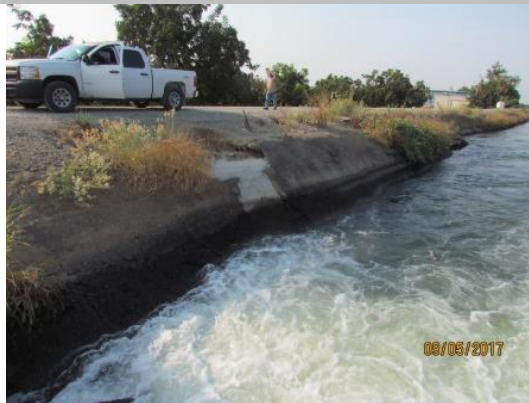
LM Start	0.56	Rating **	A/W	Issue No.	68
LM End	0.56	Issue Type +	Ob	Location *	LS
Category	Earthen Levee			GPS Latitude/Longitude	
				Start	End
Item	Erosion / Bank Caving			39.317974 °	39.317974 °
				-121.632542 °	-121.632542 °
DWR ID	DWR_MA0007_01_s_2016_68				
Comment Code					
E1 : Note and monitor erosion site.					
Inspector Comment					
Eroding slope due to irrigation ditch on landside slope has been repaired but should be monitored, Fall 2018.

View of repair to the erosion site, Fall 2018.

View of repair to the erosion site, Fall 2017.

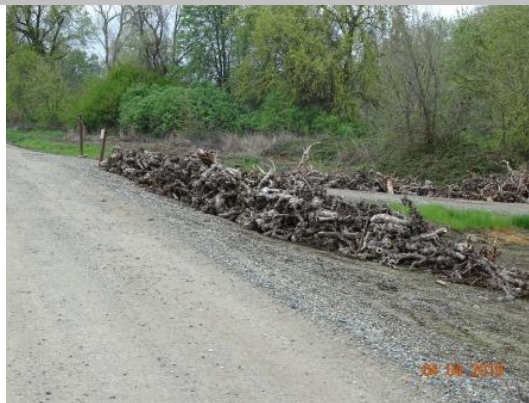
Photo 1 of 1 : SP_2019_MA0007_200_12_20190409_00030.jpg

LM Start	1.54	Rating **	M	Issue No.	12
LM End	1.54	Issue Type +	En	Location *	WS
Category	Earthen Levee			GPS Latitude/Longitude	
				Start	End
Item	Encroachments			39.331845 °	39.331845 °
				-121.633220 °	-121.633220 °
DWR ID	DWR_MA0007_01_s _ 2019_12				
Comment Code					
PR : Prunings					
Inspector Comment					
Remove prunings from levee slope, Spring 2019.

View looking upstream waterside of prunings placed on the levee slope, Spring 2019.

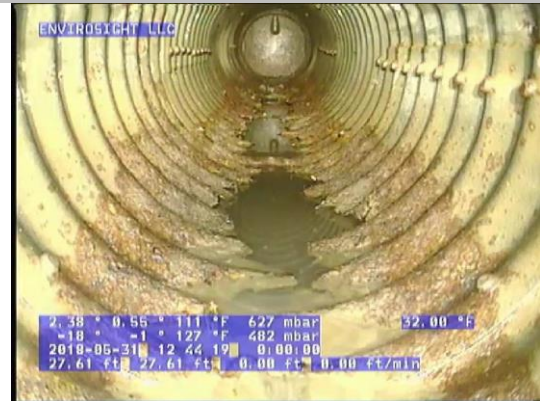
Photo 1 of 3 : UCIP_SP_2019_53989_79201.jpg

FS_ID:53989
DS_ID:16928
EP_NO: N/A
Repair Type: Urgent
Crossing Status: Found
UCIP Comments: 05/08/2019 LMA Supervisor, Shawn Freitag, has completed a temporary repair to prevent water from flowing from LS irrigation ditch to WS. Burrow hole on LS has been plugged and concrete bags have been placed to prevent water from entering the pipe and causing further damage to the pipe section through levee. Crossing will continued to be monitored by LMA. Need to coordinate with DWR DMP to address permanent solution for abandoned crossing. (O. Magana - DWR UCIP) 05/07/2019 DWR UCIP was notified by LMA Supervisor, Shawn Freitag, of pipe leak observed on LS and causing flooding to WS. Burrow hole is allowing flow to enter pipe. Hole present on pipe section near the concrete headwall. Erosion (sloughing) observed on LS slope. Pipe section tied to WS concrete box that runs parallel to levee was flooding Kiwi Orchard. Section of concrete distribution box was removed to allow for proper drainage and prevent flooding to Kiwi Orchard. Measures by LMA Supervisor are being pursued to stop flow through pipe to prevent further erosion damage through the levee (damage identified during DWR DMP Phase 1 internal video inspection). Record has been updated to reflect the DMP Phase 1 inspection report, crossing has been upgraded from Non-Urgent to Urgent based on the condition of the pipe through the levee. (O. Magana - DWR UCIP)12/07/2018 Encroachment owner information: Sukhraj Singh Pamma, 9850 Sheldon Avenue, Live Oak, CA 95953-9784, 1-530-695-2490. The CVFPB sent an encroachment violation notice on August 16, 2011 to Mr. and Ms. Ratana. Information obtained from the Levee_Encroachment_listing_11288.pdf which was received from SBFCA. Need to coordinate with CVFPB to determine status of permit. (O. Magana - DWR UCIP) 08/09/2017 Crossing is still present, no modifications were made to this crossing. Crossing still appears to be abandoned and not in use, recommend contacting owner to determine status of crossing. This pipe was not part of the Feather River West Levee Improvements, Project D. Pipe is located outside the project limits. Project Improvements began at Station (Sta) 1765+00 (MA0007 about LM 1.73) to Sta 2303+50 (ST0005 about LM 1.23), refer to record drawings for the Feather River West Levee Improvement Plans Station 1765+00 to 2368+26, Project D details. (DWR UCIP - O. Magana)08/02/2017 Unknown if crossing was modified, not shown in record drawings. (DWR UCIP - O. Magana) 05/16/2016 Feather River West Levee Improvement Project--Levee currently under construction.06/10/2015 Same as last inspection.12/29/2014 Same as last inspection.05/19/2014 Same as last inspection.11/06/2013 Same as last inspection.05/13/2013 SBFCA project recommends replacing in accordance with title

LS view: Internal view of pipe condition during DMP Phase 1 Inspection.

23.05/10/2013 Same as last inspection. LS scour behind structure needs to be repaired. 10/31/2012 crossing appears abandoned, slide gate is missing on landward side; wood frame remains on LS; scour hole present on LS, 3 feet by 3 feet, near wood frame. (DWR UCIP - O. Magana)

FIELD_STRUCT_DESC: *ABANDONED* 12-inch corrugated metal drainage pipe through the levee, 8.2 feet below the crown. Slide gate on the landside (LS) is no longer present. Concrete "U" headwall at the waterside (WS) toe. Irrigation ditch located on the LS. [Additional Reference(s): DWR Levee Log, 2005]
FS Date: 5/7/2019 12:40:00 PM

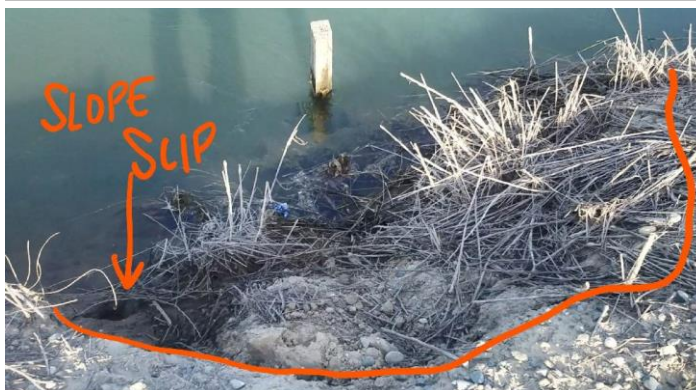
Photo 2 of 3 : UCIP_SP_2019_53989_79230.jpg

LS view: section of levee has slipped at pipe crossing.

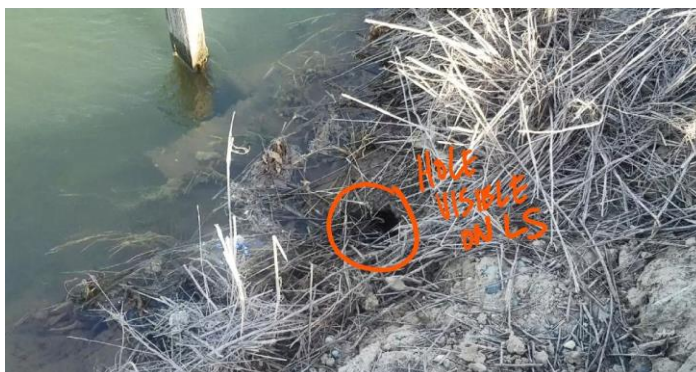
Photo 3 of 3 : UCIP_SP_2019_53989_79229.jpg

LS view: hole visible on LS, appears to be linked to burrow hole that is allowing flow to go into pipe.

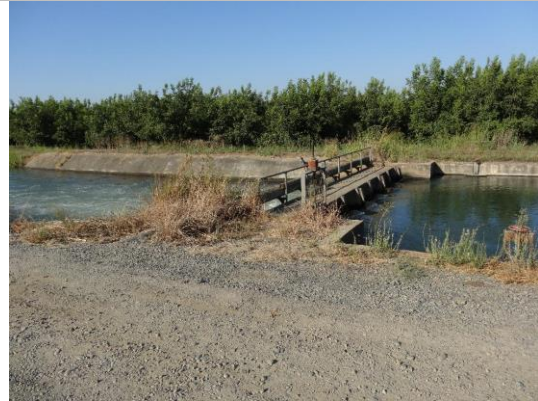
Photo 1 of 3 : UCIP_SP_2019_53948_77330.jpg

FS_ID:53948
DS_ID:20816
EP_NO: N/A
Repair Type: Non-Urgent
Crossing Status: Found
UCIP Comments: 05/07/2019 (O. Magana - DWR UCIP)12/07/2018 New encroachment owner information: Sukhraj Singh Pamma, 9850 Sheldon Avenue, Live Oak, CA 95953-9784, 1-530-695-2490. Information obtained from the Levee_Encroachment_listing_11288.pdf received from SBFCA. The permit listed in the pdf file is 11987. This permit was issued to the Cox Brothers in 1977. Need to have new owner apply for Permit Name Change with the CVFPB. (O. Magana - DWR UCIP)
08/09/2017 It appears that this pipe is used to water the orchard located on the WS. Dense vegetation present along the WS slope, recommend clearing vegetation to allow for proper inspection of levee slope. No permit has been identified since 2012. (DWR UCIP - O. Magana)08/02/2017 After reviewing record drawings it appears this crossing has remained. This pipe was not part of the Feather River West Levee Improvements, Project D. Pipe is located outside the project limits. Project Improvements began at Station (Sta) 1765+00 (MA0007 about LM 1.73) to Sta 2303+50 (ST0005 about LM 1.23), refer to record drawings for the Feather River West Levee Improvement Plans Station 1765+00 to 2368+26, Project D details. (DWR UCIP - O. Magana)

05/16/2016 Feather River West Levee Improvement Project--Levee currently under construction.06/10/2015 Crossing has been modified since last inspection. 3' black plastic pipe is now running through the metal pipe and the difference was capped and welded. 12/29/2014 Same as last inspection.05/19/2014 Same as last inspection.11/06/2013 Same as last inspection.05/13/2013 SBFCA project recommends removal. Permit number and owner in detailed report book.05/07/2013 Same as last inspection. Recommend finding owner.10/30/2012 Crossing was installed about 1 foot deep--need permit authorizing wrk. (DWR UCIP - O. Magana) FIELD_STRUCT_DESC: 12-inch steel irrigation pipe through the levee, 1 foot below the crown. Crossing on the landside (LS) is attached to a weir above ground. Siphon breaker located on the waterside (WS). No opening on the WS. No permit has been identified since crossing was field discovered in 2012. (12-inch pipe across the berm, levee, and Sutter-Butte Canal was authorized under Permit 11987, 1977 - Cox Brothers). [Additional Reference(s): Sutter Butte Flood Control Agency (SBFCA) Feather River West Levee Project, Volume 4 of 6 (Project D) Feather River West Levee Improvement Plans Sta 1765+00 to 2368+26, 2016, Volume 4-SBFCA_Record_Drawings_Project D_2017.05.16.pdf, Drawing No. C-101].

LS view: pipe visible along LS canal.

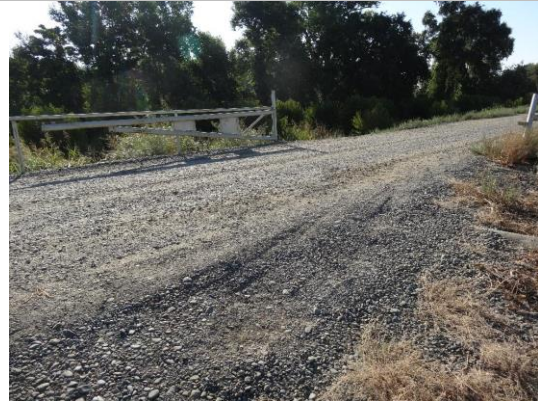
Photo 2 of 3 : UCIP_SP_2019_53948_77331.jpg

Overview of levee crown at crossing looking downstream.

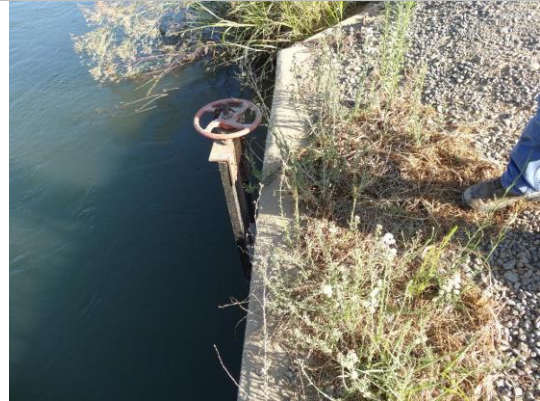
Photo 1 of 3 : UCIP_SP_2019_53949_77335.jpg

FS_ID:53949
DS_ID:16927
EP_NO: N/A
Repair Type: Non-Urgent
Crossing Status: Found
UCIP Comments: 05/07/2019 (O. Magana - DWR UCIP)12/07/2018 Encroachment owner information: Sukhraj Singh Pamma, 9850 Sheldon Avenue, Live Oak, CA 95953-9784, 1-530-695-2490. Information obtained from the Levee_Encroachment_listing_11288.pdf which was received from SBFCA. Need to coordinate with CVFPB to determine status of permit. (O. Magana - DWR UCIP)
08/09/2017 Crossing is still present, unable to confirm if crossing is still in use. Recommend contacting owner to determine status, remove dense vegetation blocking outlet, and to obtain permit authorizing crossing. (DWR UCIP - O. Magana) 08/02/2017 After reviewing record drawings it appears this crossing has remained. This pipe was not part of the Feather River West Levee Improvements, Project D. Pipe is located outside the project limits. Project Improvements began at Station (Sta) 1765+00 (MA0007 about LM 1.73) to Sta 2303+50 (ST0005 about LM 1.23), refer to record drawings for the Feather River West Levee Improvement Plans Station 1765+00 to 2368+26, Project D details. (DWR UCIP - O. Magana)

05/16/2016 Feather River West Levee Improvement Project--Levee currently under construction.06/10/2015 WS headwall is still damaged and no repairs were made to this pipe. Looks like the SBFCA project skipped over this area so pipe was not replaced as it was listed to be.12/29/2014 Same as last inspection.05/19/2014 Same as last inspection.11/06/2013 Same as last inspection.05/13/2013 SBFCA project recommends replacing with accordance to title 23.05/07/2013 Same as last inspection, however exposed rebar on WS headwall does not impede structure performance.10/31/2012 WS headwall rebar exposed. This crossing was listed in the USACE Periodic Inspections as ID# USACE_CESPK_MA07_2010_a_0051 however, no issue listed. (DWR UCIP - O. Magana)
FIELD_STRUCT_DESC: 10-inch polyvinyl chloride (PVC) pipe encased in a 12-inch corrugated metal irrigation pipe through the levee, 7 feet below the crown. Concrete U-shaped headwall at the waterside (WS) toe. Concrete headwall and slide gate on the landside (LS). Concrete weir in the canal. (Existing 10-inch PVC pipe and 12-inch corrugated metal [concrete indicated in record drawings] irrigation pipe crossing remained during the Feather River West Levee Improvements, Project D). [Additional Reference(s): DWR Levee Log, 2005. Sutter Butte Flood Control Agency (SBFCA) Feather River West Levee Project, Volume 4 of 6 (Project D) Feather River West Levee Improvement Plans Sta 1765+00 to 2368+26, 2016, Volume 4-SBFCA_Record_Drawings_Project D_2017.05.16.pdf, Drawing No. C-101].

LS view: screw gate and concrete headwall visible on LS.

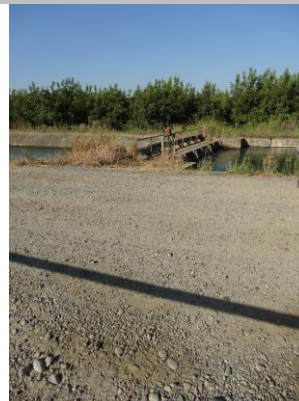
Photo 2 of 3 : UCIP_SP_2019_53949_77336.jpg

Overview of levee crown at crossing.

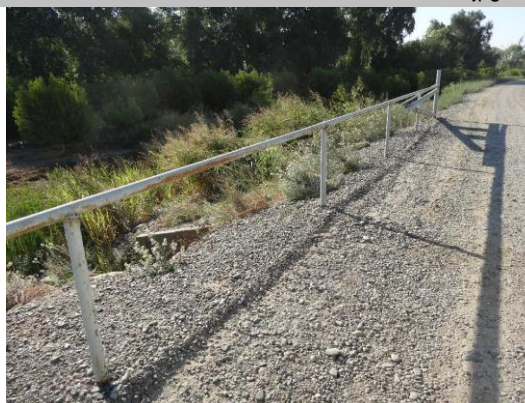
Photo 3 of 3 : UCIP_SP_2019_53949_77337.jpg

WS view: guardrail along the WS slope and concrete headwall visible on WS.

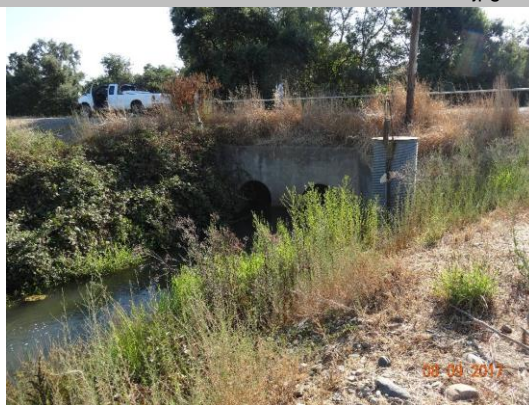
Photo 2 of 3 : UCIP_SP_2019_53950_77351.jpg

LS view: concrete headwall with dual 60-inch crossings visible from LS.

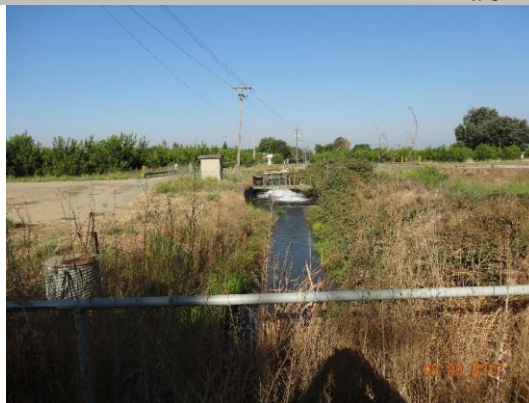
Photo 3 of 3 : UCIP_SP_2019_53950_77342.jpg

LS view: view of canal looking west from crossing.

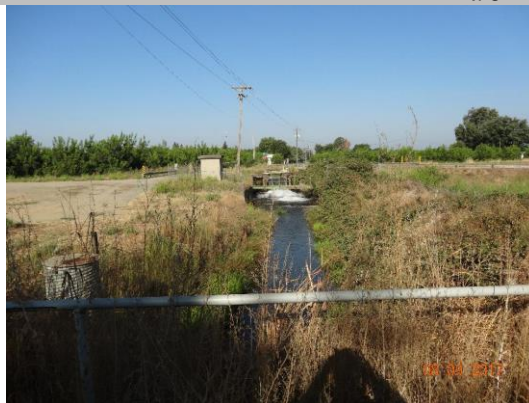
Photo 3 of 3 : UCIP_SP_2019_53951_77358.jpg

LS view: canal located on LS, photo taken from levee crown looking west.

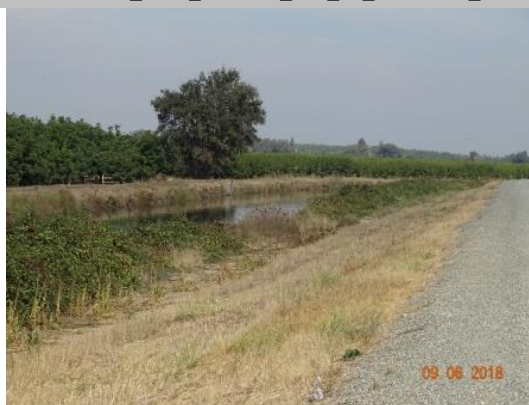
Photo 1 of 1 : SP_2019_MA0007_200_39_20190305_00003.jpg

LM Start	4.39	Rating **	M	Issue No.	39
LM End	5.35	Issue Type +	En	Location *	LS
Category	Earthen Levee			GPS Latitude/Longitude	
				Start	End
Item	Encroachments			39.366547 °	39.380071 °
				-121.647523 °	-121.650558 °
DWR ID	DWR_MA0007_01_s_2012_39				
Comment Code					
DT : Ditch					
Inspector Comment					
A landside irrigation ditch is located at the levee toe.

View looking upstream landside at an irrigation ditch at the levee toe, Fall 2018.

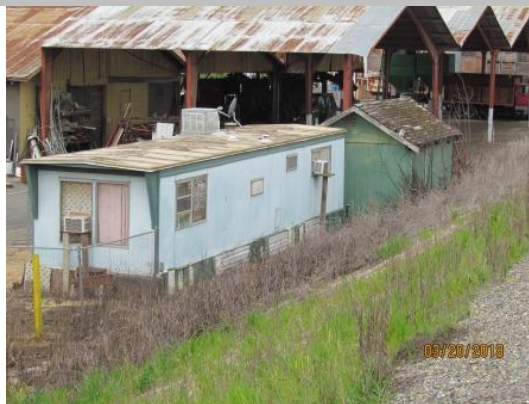
Photo 1 of 1 : SP_2019_MA0007_200_45_20190305_00005.jpg

LM Start	9.65	Rating **	U	Issue No.	45
LM End	9.65	Issue Type +	En	Location *	LS
Category	Earthen Levee			GPS Latitude/Longitude	
				Start	End
Item	Encroachments			39.416384 °	39.416384 °
				-121.634503 °	-121.634503 °
DWR ID	DWR_MA0007_01_s_2012_45				
Comment Code					
BU : Building					
Inspector Comment					
A trailer is still located at the landside levee toe, no permit found.

This photo shows a building at the landside toe, no permit found.
